# SLOPE EROSION TRANSECTS LAKE TAHOE BASIN

INTERIM REPORT

July, 1971

**NO. M & R 657078-1**

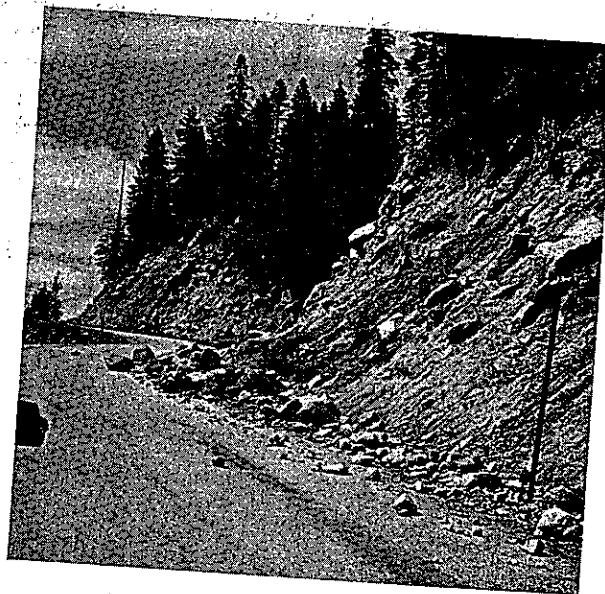
44C Old Meyers Grade. 03-ED

There are six cut slopes located on the left with south and southeast facing aspects that appear to account for the erosion rates listed above. The physical descriptions of these slopes are:

P.M.	to	P.M.	DIST.	ANGLE	CY/YR EROSION
0.31		0.36	300'	35°	5
0.42		0.63	1,110'	44°	30
0.63		0.74	580'	45°	80
0.77		0.92	790'	41°	60
0.92		1.12	1,060'	41°	60
1.12		1.26	740'	37°	40

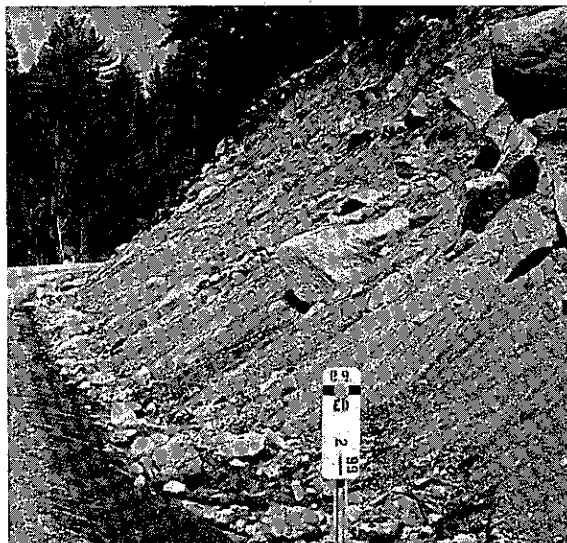
44D Grass Lake Creek. 03-ED-89

There are eight cut slopes on the right, six cut slopes on the left, and one fill slope on the right and left, respectively, that appear to account for the erosion quantities listed above. The physical descriptions of these slopes follows:

PM	to	PM	DIST.	C/F	R/L	ASPECT	ANGLE	CY/Yr EROSION
1.87		1.97	530'	C	R	S	35°	54
1.93		1.97	200'	F	L	S	35°	1
2.04		2.11	420'	C	R	S	34°	32
2.14		2.20	320'	C	R	S	39°	25
2.36		2.52	840'	C	R	S	34°	108
2.59		2.64	260'	C	R	S	45°	5
2.72		2.81	480'	C	R	S	39°	4
2.93		2.99	320'	C	L	N	35°	20
3.10		3.17	370'	C	L	N	30°	3
3.13		3.14	50'	C	R	S	25°	1
3.30		3.54	1260'	C	L	N	35°	6
3.81		3.87	350'	C	L	N	45°	0
3.99		4.09	530'	C	L	NE	35°	1
4.30		4.45	800'	C	R	SW	35°	36

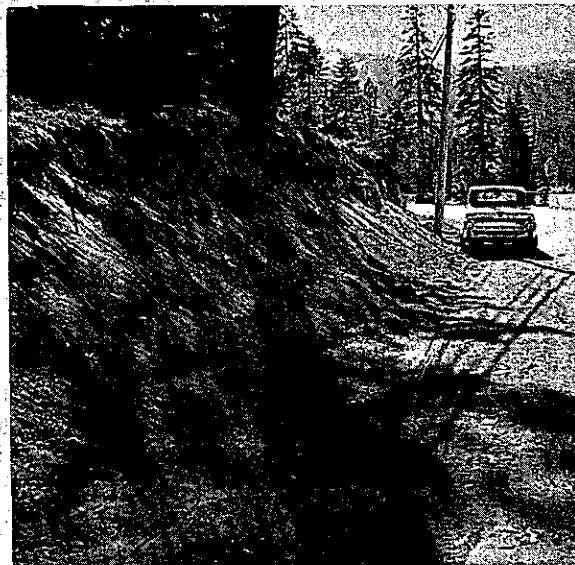
58 Quail Lake. 03-Pla-89

There are three cut slopes located on the left with an east aspect that appear to account for the erosion quantities listed above. Listed below are physical descriptions of these cuts:

P.M.	to	P.M.	DIST.	ANGLE	CY/Yr EROSION
1.13		1.18	260'	vertical	32
1.18		1.27	470'	45°	37
1.27		1.40	700'	32°	10

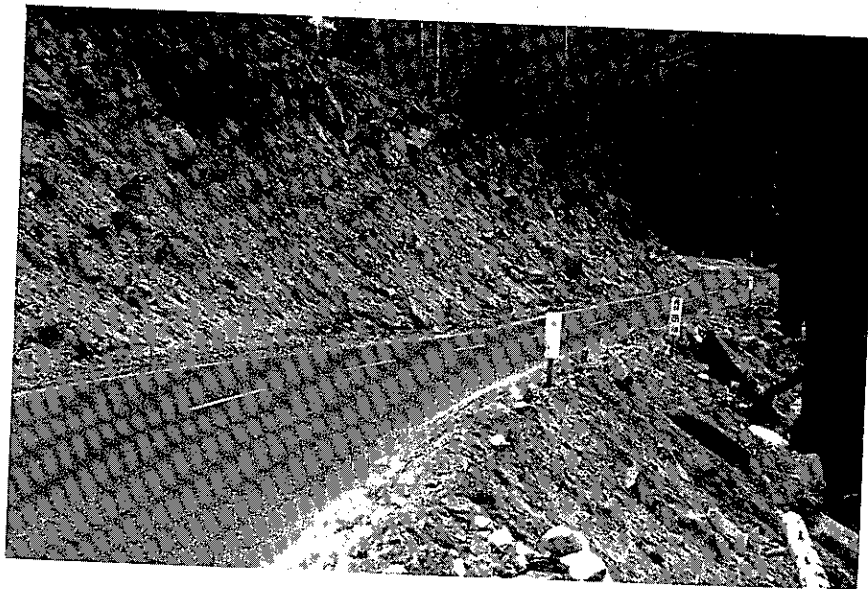
49A Unnamed (Emerald Bay). 03-ED-89

There are seven cut slopes located on the left side of the highway that account for the erosion quantities listed above. The following is a description of the cuts:

P.M.	to	P.M.	DIST.	ASPECT	ANGLE	CY/Yr EROSION
15.34		15.47	680'	N	42°	2
15.47		15.52	260'	E	29°	2.5
15.62		15.72	500'	N	30°	.1
15.97		16.15	900'	N	44°	55
16.31		16.44	700'	N	50°	27
16.44		16.50	350'	N	50°	14
16.50		16.54	200'	E	var.	25

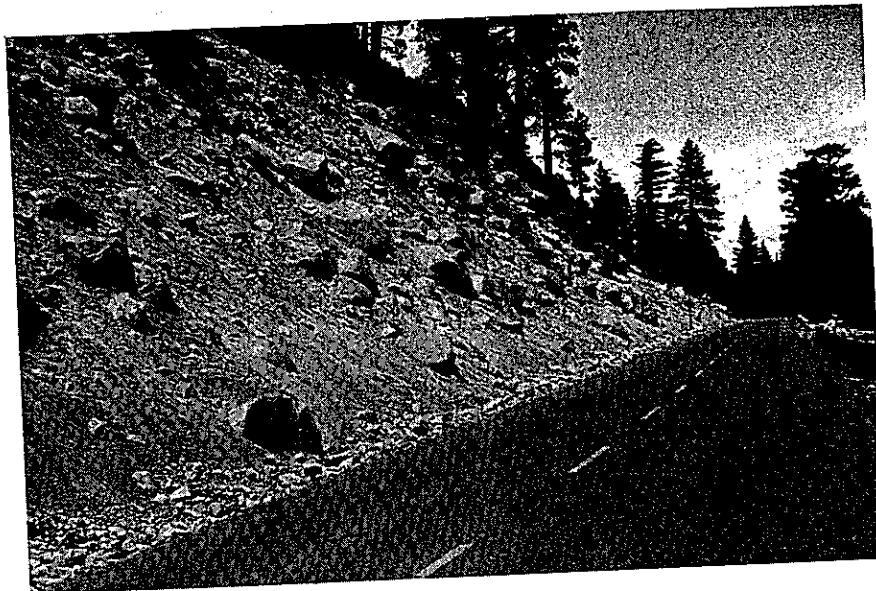
49C Unnamed (Emerald Bay). 03-ED-89

There are three cut slopes located on the left side of the highway that account for the erosion quantities listed above. The following is a description of the cuts:

P.M.	to	P.M.	DIST.	ASPECT	ANGLE	CY/Yr EROSION
17.58		17.69	580'	S	var.	35
17.75		18.02	370'	S	var.	30
8.40		18.50	530'	E	var.	0

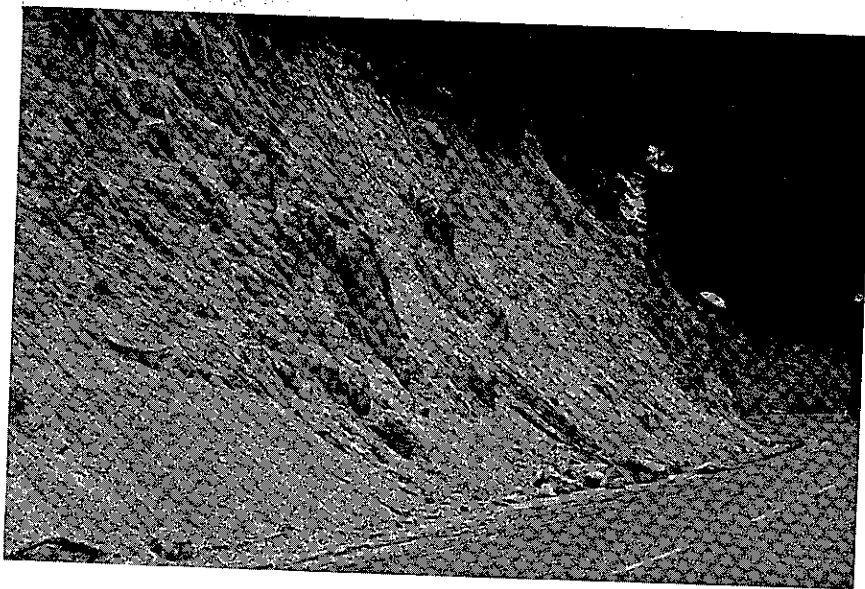
49B Eagle Creek (Emerald Bay). 03-ED-89

There are three cut slopes located on the left side of the highway and one fill slope on the right that accounts for the above erosion quantities. A description of these slopes follows:

P.M.	to	P.M.	DIST.	C/F	ASPECT	ANGLE	CY/Yr EROSION
16.54		16.61	370'	C	E	var.	7
16.79		16.81	100'	C	E	var.	10
16.85		16.87	100'	C	E	var.	3
17.13		17.15	100'	F	E	var.	1

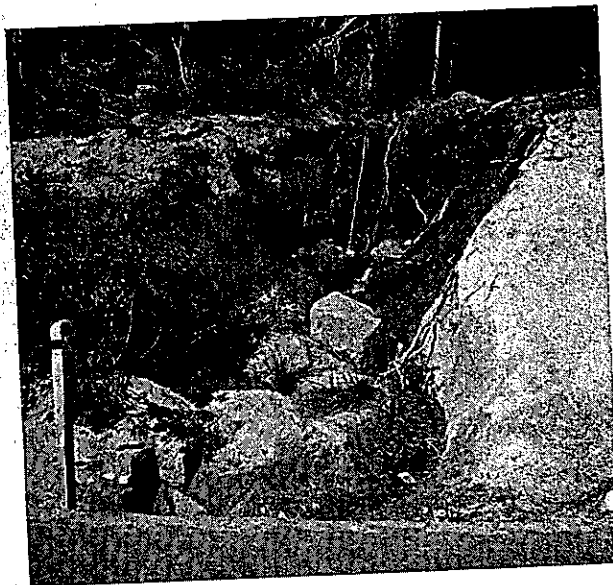
50 Unnamed. 03-ED-89

There are four cut slopes that account for the erosion quantities listed above. A description of the cuts follows:

P.M.	to	P.M.	DIST.	R/L	ASPECT	ANGLE	CY/Yr EROSION
18.75		19.20	2400'	L	E	var.	40
18.75		19.00	1300'	R	W	var.	6
19.29		19.32	160'	L	E	var.	10
19.29		19.34	260'	R	W	var.	20

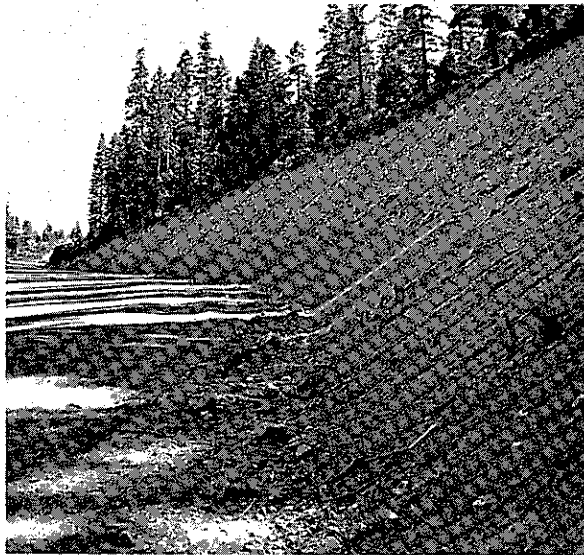
5 Dollar Creek. 03-Pla-28

There are five cut slopes and two fill slopes that account for the erosion quantities listed above. A description of the slopes follows:

<u>P.M.</u>	<u>to</u>	<u>P.M.</u>	<u>DIST.</u>	<u>C/F</u>	<u>R/L</u>	<u>ASPECT</u>	<u>ANGLE</u>	<u>CY/Yr EROSION</u>
3.00		3.14	750'	C	R	NE	36°	1
3.00		3.14	750'	C	L	SW	35°	12
3.20		3.28	400'	C	R	NE	43°	12
3.21		3.38	550'	C	L	SW	39°	17
3.38		3.44	300'	C	L	SE	40°	10
3.44		3.50	300'	F	L	NE	34°	1
3.44		3.54	500'	F	R	SW	36°	1

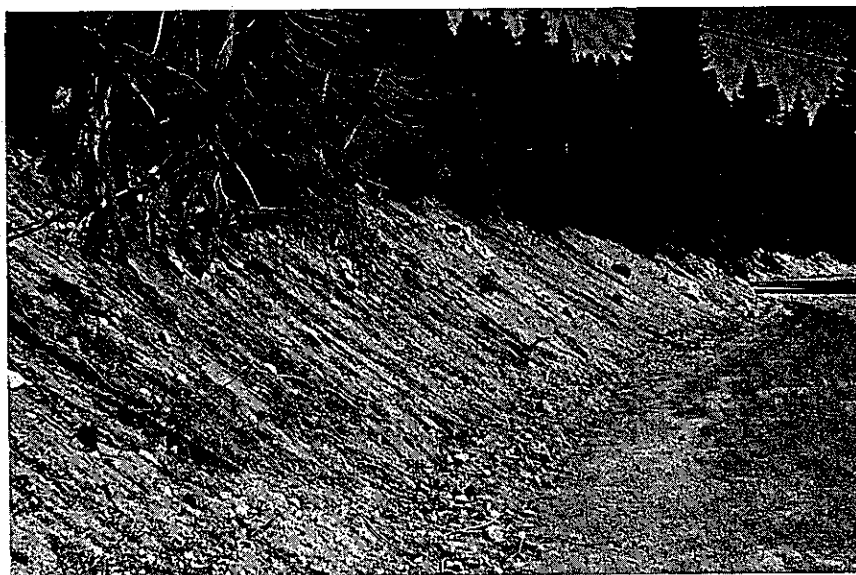
47 Tallac. 03-ED-89

There are six cut slopes located on the left side of the highway that account for the erosion quantities listed above. A description of these cut slopes follows:

<u>P.M.</u>	<u>to</u>	<u>P.M.</u>	<u>DIST.</u>	<u>ASPECT</u>	<u>ANGLE</u>	<u>CY/Yr EROSION</u>
12.83		12.94	600'	E	vert.	.9
13.44		13.73	1500'	E	30°	2.5
13.73		13.77	200'	E	33°	7
13.77		14.18	2150'	E	35°	16
14.18		14.22	220'	E	32°	27
14.22		14.30	420'	E	36°	3

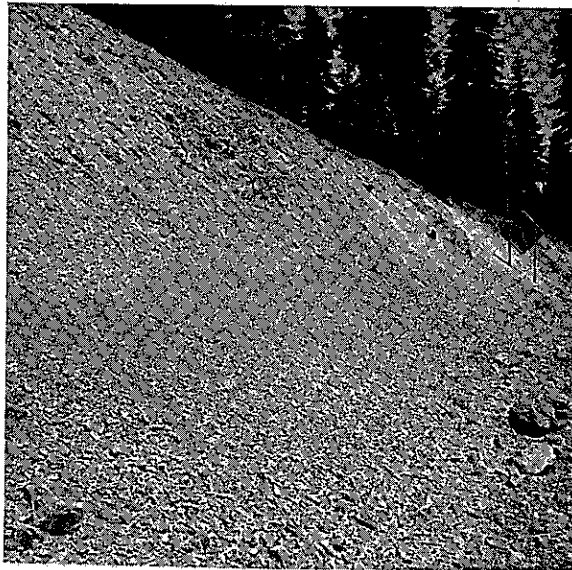
10B Snow Creek. 03-Pla-267

The upper reaches of the Snow Creek Watershed are traversed by Highway 267 from Brockway Summit to Kings Beach. The post mile limits on Highway 267 are 6.69 to 9.07.

1970-71 CY/Yr		Long Term CY/Yr		1970-71 CY/Mi. Slope/Yr		1970-71 CY/Mi. Hwy/Yr	
<u>Displ.</u>	<u>Str.</u>	<u>Displ.</u>	<u>Str.</u>	<u>Displ.</u>	<u>Str.</u>	<u>Displ.</u>	<u>Str.</u>
60	6	34	3	33	3	19	2

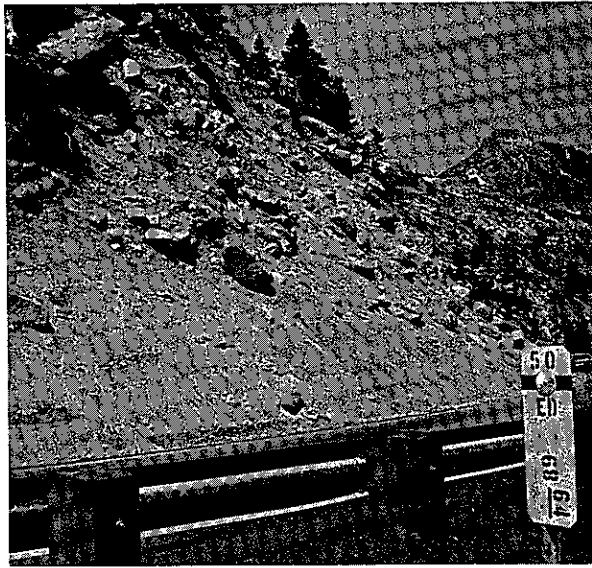
44C Upper Truckee River. 03-ED-50

Highway 50 traverses the Upper Truckee River Watershed from Echo Summit, and then follows Meyers Grade to the town of Meyers at the junction with Highway 89. The post mile limits for 44C are 66.94 to 70.03.

1970-71 CY/Yr		Long Term CY/Yr		1970-71 CY/Mi. Slope/Yr		1970-71 CY/Mi. Hwy/Yr	
<u>Displ.</u>	<u>Str.</u>	<u>Displ.</u>	<u>Str.</u>	<u>Displ.</u>	<u>Str.</u>	<u>Displ.</u>	<u>Str.</u>
35	6	24	4	21	4	11	2

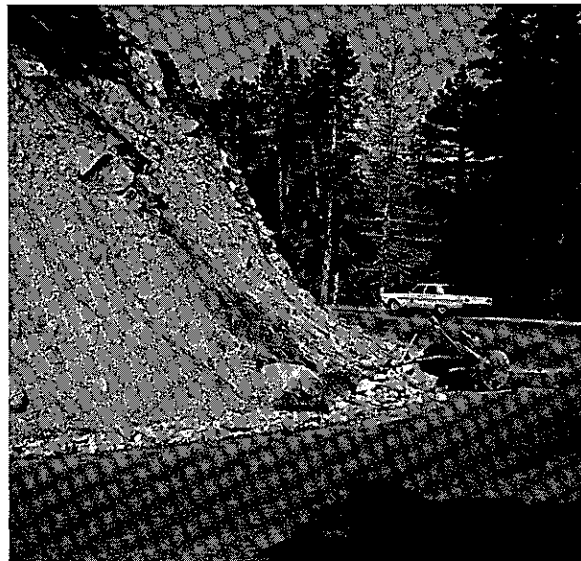
48 Cascade Creek. 03-ED-89

A description of the slopes that appear to be the main contributors of the erosion rates listed are:

<u>P.M.</u>	<u>to</u>	<u>P.M.</u>	<u>DIST.</u>	<u>C/F</u>	<u>R/L</u>	<u>ASPECT</u>	<u>ANGLE</u>	<u>CY/Yr EROSION</u>
14.30		14.36	200'	C	L	E	41°	3.1
14.41		14.46	270'	C	L	N	28°	1.2
14.48		14.49	60'	C	L	N	45°	.1
15.00		15.26	1400'	C	L	S	32°	5.5

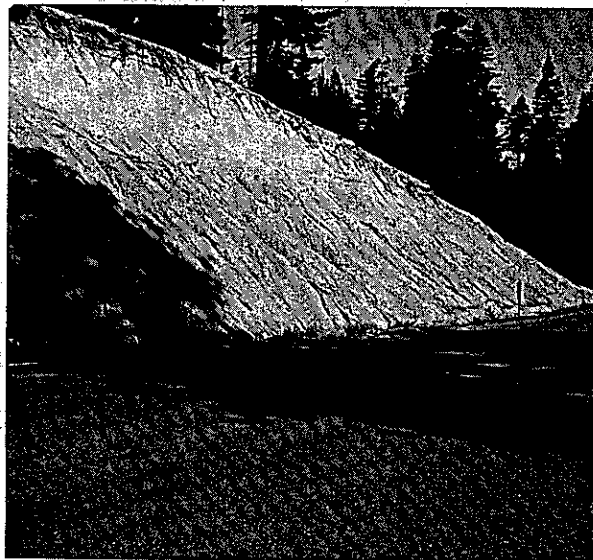
51 Rubicon Creek. 03-ED-89

A description of the slopes contributing the bulk of the erosion rates listed above are:

<u>P.M.</u>	<u>to</u>	<u>P.M.</u>	<u>DIST.</u>	<u>C/F</u>	<u>R/L</u>	<u>ASPECT</u>	<u>ANGLE</u>	<u>CY/Yr</u>	<u>EROSION</u>
19.47		19.52	500'	C	L	E	25°	2	
19.83		19.85	120'	C	L	E	46°	1	
19.90		19.94	100'	C	L	E	Var.	.5	
20.00		20.03	150'	C	L	E	42°	.3	
20.11		20.16	260'	C	L	E	38°	2	
20.14		20.16	100'	C	R	W	35°	.7

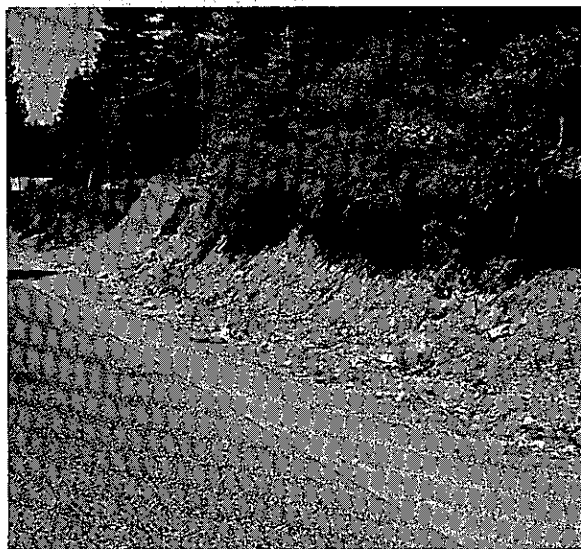
63 Ward Creek. 03-Pla-89

<u>P.M.</u>	<u>to</u>	<u>P.M.</u>	<u>DIST.</u>	<u>C/F</u>	<u>R/L</u>	<u>ASPECT</u>	<u>ANGLE</u>	<u>CY/Yr</u>	<u>EROSION</u>
6.03		6.06	150'	C	L	E	32°	1	
6.03		6.06	150'	C	R	W	26°	.3	
6.14		6.16	100'	C	L	E	Var.	.3	
6.80		6.81	50'	C	L	E	Var.	.5	
6.83		7.00	900'	C	L	E	Var.	1	
7.00		7.09	480'	C	L	E	Vert.	3	
7.18		7.43	1300'	C	L	E	28°	3

It was noted that from post mile 4.13 to 5.73, construction of a sewer line along the road shoulder precluded obtaining any meaningful data on slope erosion.

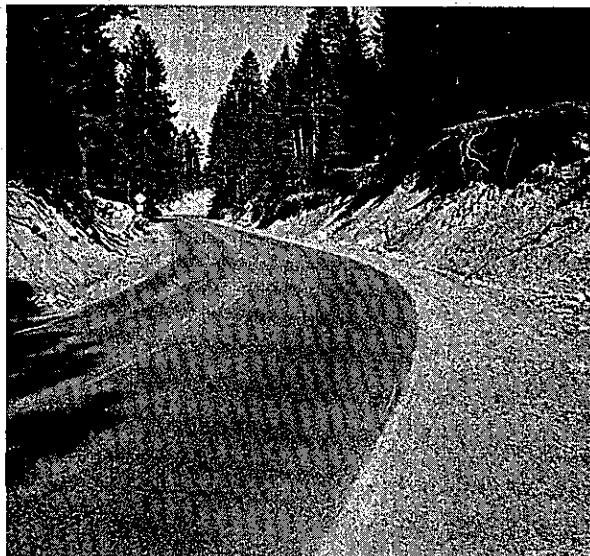
54 Rubicon Units. 03-ED-89

A description of the slopes for this watershed which appear to be the main contributors follows:

<u>P.M.</u>	<u>to</u>	<u>P.M.</u>	<u>DIST.</u>	<u>C/F</u>	<u>R/L</u>	<u>ASPECT</u>	<u>ANGLE</u>	<u>CY/Yr</u>	<u>EROSION</u>
22.71		22.73	100'	C	R	W	Var.	.5	
22.73		22.85	300'	C	L	N	40°	5	
22.85		22.87	100'	C	R	S	34°	2	
23.23		23.28	300'	C	L	E	29°	2	
23.31		23.42	580'	C	L	E	30°	.5	
23.43		24.11	3600'	C	L	E	30°	.2

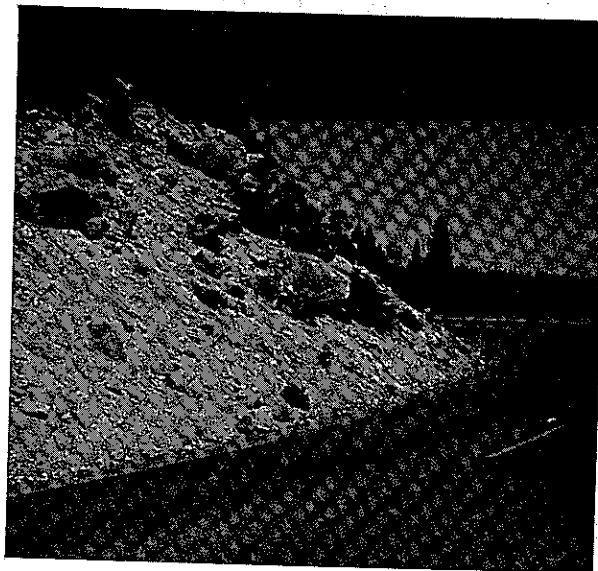
55A Meeks Creek. 03-ED-89

A description of the slopes that appear to contribute to this quantity is as follows:

<u>P.M.</u>	<u>to</u>	<u>P.M.</u>	<u>DIST.</u>	<u>C/F</u>	<u>R/L</u>	<u>ASPECT</u>	<u>ANGLE</u>	<u>CY/Yr EROSION</u>
24.24		24.44	1000'	C	L	E	35°	1.5
24.53		24.64	580'	C	L	E	35°	2
24.53		24.55	100'	C	R	W	Var.	1
25.13		25.19	320'	C	L	E	Var.	1
25.13		25.16	160'	C	R	W	Var.	.1
25.24		25.26	100'	C	L	E	Var.	.1
25.38		25.44	320'	C	L	E	34°	3

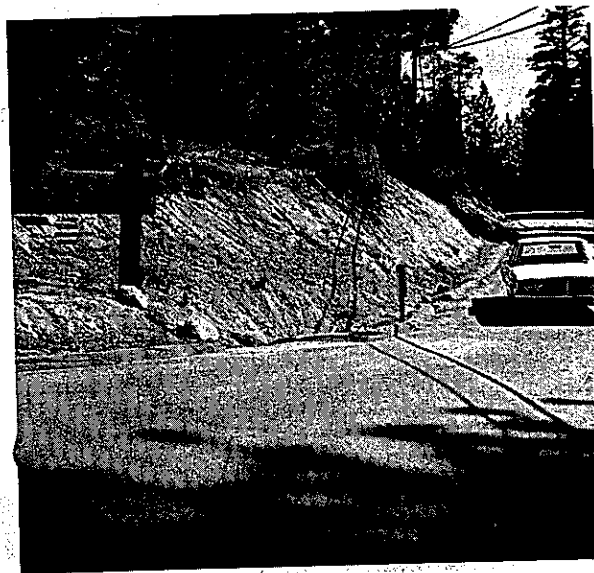
55B Unnamed. 03-ED-89

A description of the slopes within the watershed that appear to account for these rates are as follows:

<u>P.M.</u>	<u>to</u>	<u>P.M.</u>	<u>DIST.</u>	<u>C/F</u>	<u>R/L</u>	<u>ASPECT</u>	<u>ANGLE</u>	<u>CY/Yr</u>	<u>EROSION</u>
25.55		25.56	60'	C	L	E	Vert.	.5	
25.58		25.62	250'	C	L	E	30°	.5	
25.58		25.60	100'	C	R	W	Vert.	1	
25.63		25.75	600'	C	L	E	Var.	1
